Incidence and Causes of Physical Failure of Artificial Habitat Structures in Streams of Western Oregon and Washington

CHRISTOPHER A. FRISSELL AND RICHARD K. NAWA

*Oak Creek Laboratory of Biology
 Department of Fisheries and Wildlife, Nash Hall 104
 Oregon State University, Corvallis, Oregon 97331, USA*

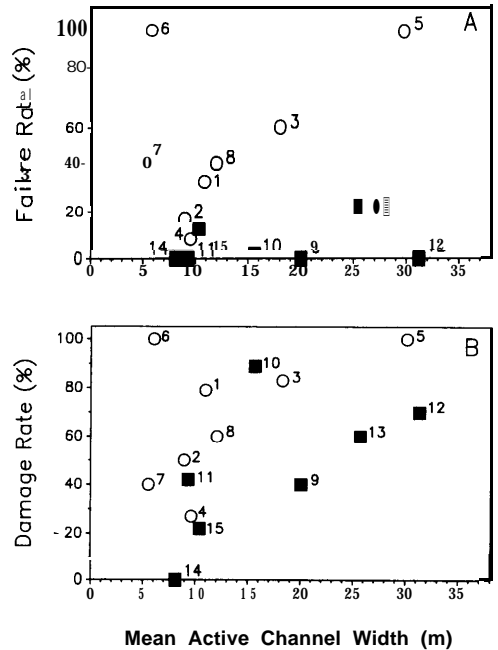
Rates of damage were higher in larger and wider streams (Figure 2B). Projects in streams with active channel widths wider than 15 m had a median damage rate of 79% (range, 50-100; N = 6) whereas those with active channels narrower than 15 m were highly variable and had a median damage rate of 50% (range = 0-100; N = 9). Southwest Oregon data suggested a roughly linear increase in failure rate with stream width (Figure 2A). In southwest Washington, failure rate apparently was not correlated with stream width, although impairment and therefore damage rate were correlated with stream size. There was no clear relationship between drainage basin area and failure or damage rates. Because climatic and hydrologic characteristics of individual streams vary within a region, active channel width is a better site-specific, integrated measure of streamflow and asso-

FIGURE 2.- (A) Failure and (B) damage rates of projects in southwest Oregon (open circles) and southwest Washington (solid squares) in relation to active channel width. Stream numeric codes are given in Figure 1. Damage rate includes both failed and impaired structures.

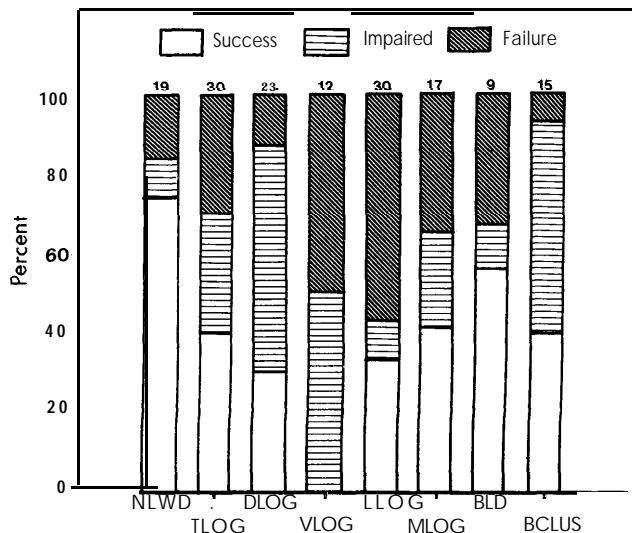
Of the eight structure designs for which we had sufficient sample size, only two-cabled natural woody debris and individual boulder placements were not impaired or did not fail in more than half the cases (Figure 3). All log weir designs had high rates of impairment or failure, and one type, the downstream-V weir, failed or was impaired in every instance. Boulder structures had lower failure rates than log weirs. Previous studies have shown low failure rates for boulder structures in streams of less than 2% gradient but higher failure rates in steeper streams (Hamilton 1989). Although many boulders had been almost completely buried in place by bed-load deposits, we classified these as impairments rather than failures, because they might someday be reexcavated by the stream.

FIGURE 3. Failure and impairment rates of structures classified by design. Number at top of each bar indicates the number of structures in the sample. NLWD = cabled natural large woody debris or jam; TLOG = transverse log weir; DLOG = diagonal log weir; VLOG = downstream-V log weir; LLOG = lateral log deflector; MLOG = multiple-log structure; BLD = individually placed boulders; BCLUS = clustered boulders.

presented in Figure 3 are biased because not all designs were represented in all streams. For example, the higher success rate of boulder projects is partly related to their concentration in relatively stable southwest Washington streams where damage to structures of all types was small.

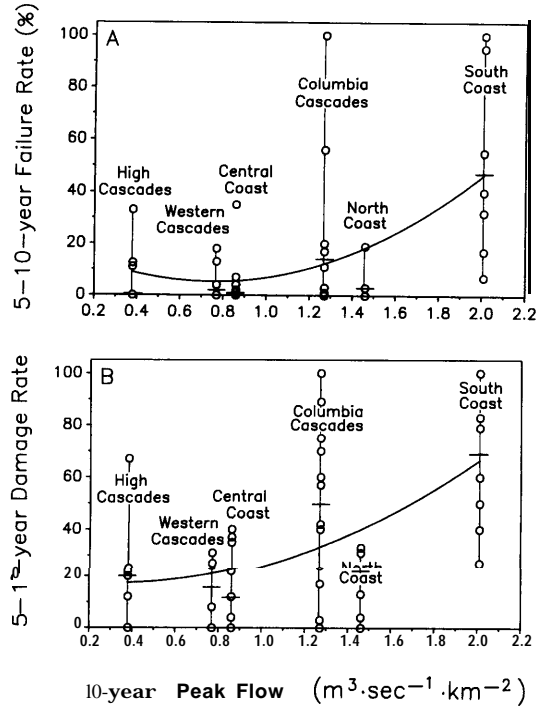
When we compared our results with data from other regions in western Oregon (Appendix 1), we found that the projects we studied had higher-than-average rates of impairment and failure. However, the projects we evaluated were in regions with intense winter precipitation and substantially higher peak discharge than most other regions (Figure 4; Appendix 2). There was a positive relationship between impairment and failure rates and peak flows. Streams in regions characterized by 10-year-recurrence peak flows exceeding $1 \text{ m}^3 \cdot \text{s}^{-1} \cdot \text{km}^{-2}$ had high but variable rates of damage (range, 0-100%; median, 46%) and failure (range, 0-100%; median, 14%) (Figure 5).

to structures, has mean 10-year peak flows in excess of $2.0 \text{ m}^3 \cdot \text{s}^{-1} \cdot \text{km}^{-2}$. Projects in other parts of western Oregon experienced much lower peak flows and had lower rates of damage (range, 0-67%; median, 12%) and only limited incidence of failure (range, 0-35%; median, 0.5%) (Figure 5).

FIGURE 5. -Relation between rates of (A) failure and (B) overall damage of projects and regional median 10-year-recurrence peak flows standardized by drainage area. Each point represents one or more projects (full data are in Appendix 1). Horizontal bars indicate regional medians. Curves are second-order regressions fitted to indicate trend, and are not necessarily statistically significant. Southwest Washington projects from Table 2 are classified as Columbia Cascades region except for Rush Creek and Falls Creek in the High Cascades. Southwest Oregon projects from Table 2 constitute the sample for the south Coast Range-Klamath Mountains region.
