CHANNEL RECOVERY FROM RECENT LARGE FLOODS  
IN NORTH COASTAL CALIFORNIA: RATES AND PROCESSES

Thomas E. Lisle <sup>1/</sup>

ABSTRACT

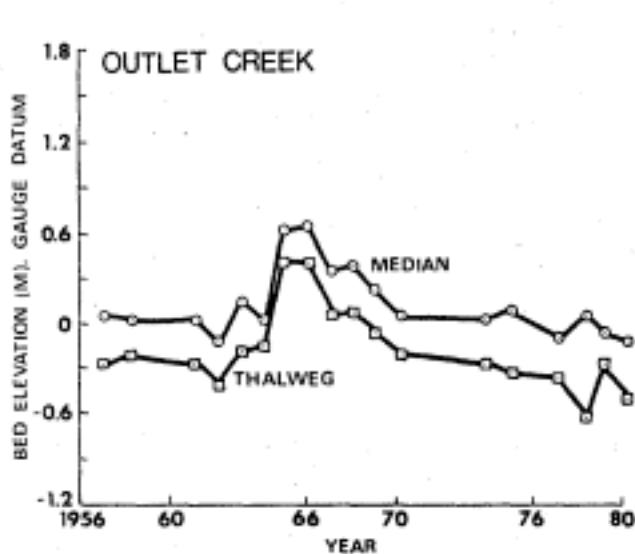
Figure 1--Changes in bed elevations of the Outlet Creek gaging section (Lisle, 1981).

An episode of aggradation consists of an initial period of relatively rapid channel filling, followed later by progressive scour or degradation to a nearly constant bed level (Figure 1).

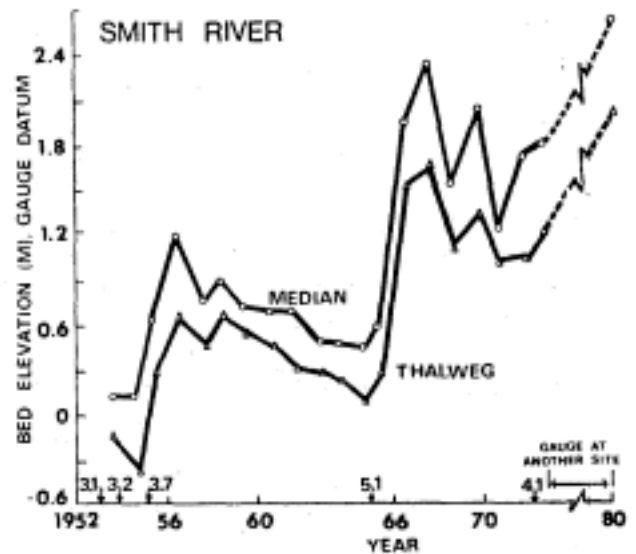
Figure 2--Changes in bed elevations of the Smith River gaging section (Lisle, 1981). The gage was located elsewhere from 1972 to 1979. Numbers above abscissa are runoff values ( $m^3/s - km^2$ ) for floods.

At some stations bed elevation returned to pre-flood levels at the end of episodes of aggradation--a period lasting a few years or more. At other stations bed elevation stabilized at a level higher than that before the flood. Data from the Smith River show three episodes of aggradation associated with floods in the early 1950's, 1964, and 1972 (Figure 2). An important factor affecting the duration of the aggradation episodes was the post-flood sequence of flows. Moderately high flows are effective in transporting sediment out of main channels. However, large floods which contribute additional sediment to channels may prolong episodes of aggradation. In the Smith River, new episodes of aggradation were started before previous episodes, had ended. Recovery of stream channels from aggradation, therefore, depends on long periods without large storms as well as the absence of new sediment. Records from 13 stream sections in northwestern California indicate that most fourth order or smaller stream

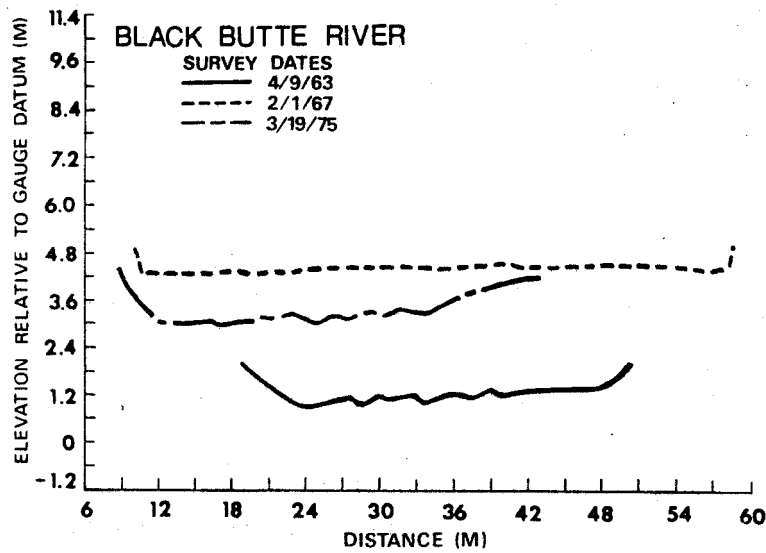
Figure 3--Soundings of the Black Butte River gaging section near Covelo.

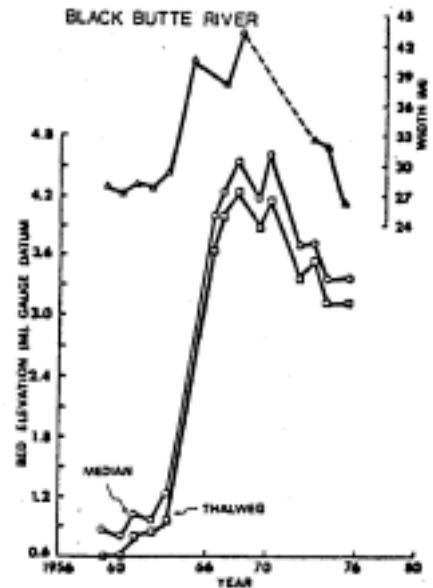
Figure 4--Changes in bed elevations and channel width of the Black Butte River gaging section near Covelo (Lisle, 1981).

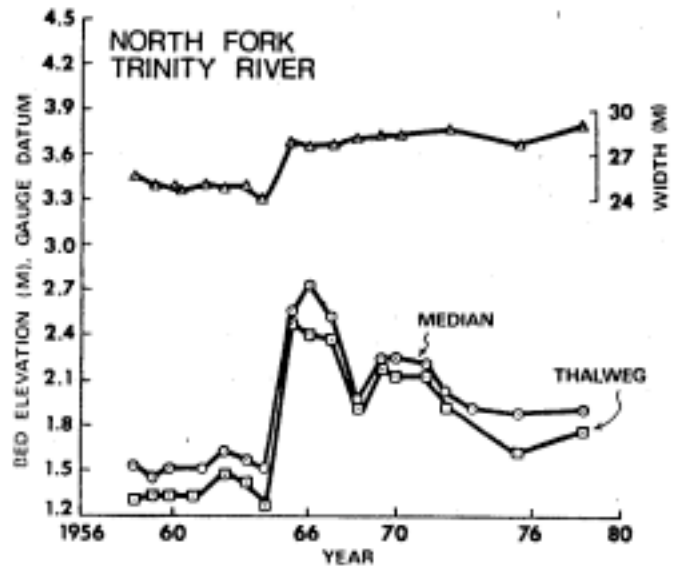
Figure 6--Changes in bed elevations and channel width of the North Fork Trinity River gaging section at Helena (Lisle, 1981).

Alluvial channels (bordered by river borne sediment) widened as much as 100 percent (Lisle, 1981). Channel narrowing was accomplished in the Black Butte cross section, for instance, by erosion into flood deposits (Figure 5). This fluvial process coincided with the degradation of the elevated streambed (Figure 6). Streambanks may also be gradually constructed by the deposition and stabilization of alluvium--a relatively slow process that depends largely on the spread and growth of riparian vegetation.
